## *Dangerous, delicate and downright ingenious*

*Fire Damaged Concrete Structure Supporting 225-Ton Vessel*

### *First Edition E-Newsletter*

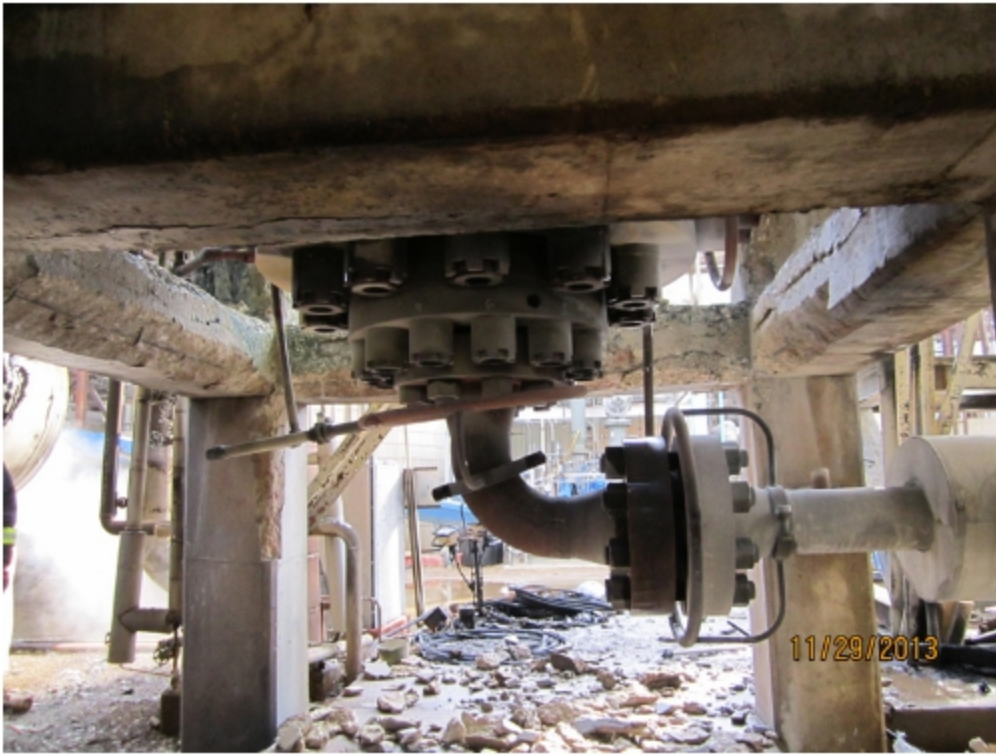
Friday, November 29, 2013, the day after Thanksgiving, a fire broke out at the Rentech Nitrogen Partners, L. P. Fertilizer Plant in East Dubuque, Illinois. The fire in the ammonia process area of the plant broke out about 9 am and was quickly extinguished by fast acting employees and the fire department. The fire left a 225-ton vessel delicately balanced on a concrete frame that had sustained serious damage.

Within hours, WHKS structural experts were assessing the damage and calculating the load-carrying ability of the damaged frame. Looking under and around the precarious structure, it appeared that cracks in the concrete were widening and the risk of catastrophic collapse was growing by the hour.

Damage to the original concrete frame was too extensive for it to be repaired. Nor was it cost effective or desirable to move the 225-ton vessel that was supported by the frame.

Based on structural evaluations performed by two independent WHKS teams, the Rentech Nitrogen team of employees and contractors used available railroad ties, steel beams and hydraulic jacks to temporarily brace the damaged frame. Survey crews set up eight independent observation points to measure any movement. The next steps were to find and install a permanent solution.

After brainstorming a variety of solutions, the team decided to encase the damaged concrete columns with a new structure made of welded steel plates. Working carefully from below ground footings, contractors proceeded upward in stages to bring the new structural system up to the underside of the vessel. In a masterful demonstration of round-the-clock, fast-track construction, the upper stages were being designed, materials sourced, and parts fabricated while the earlier stages were being constructed on site.

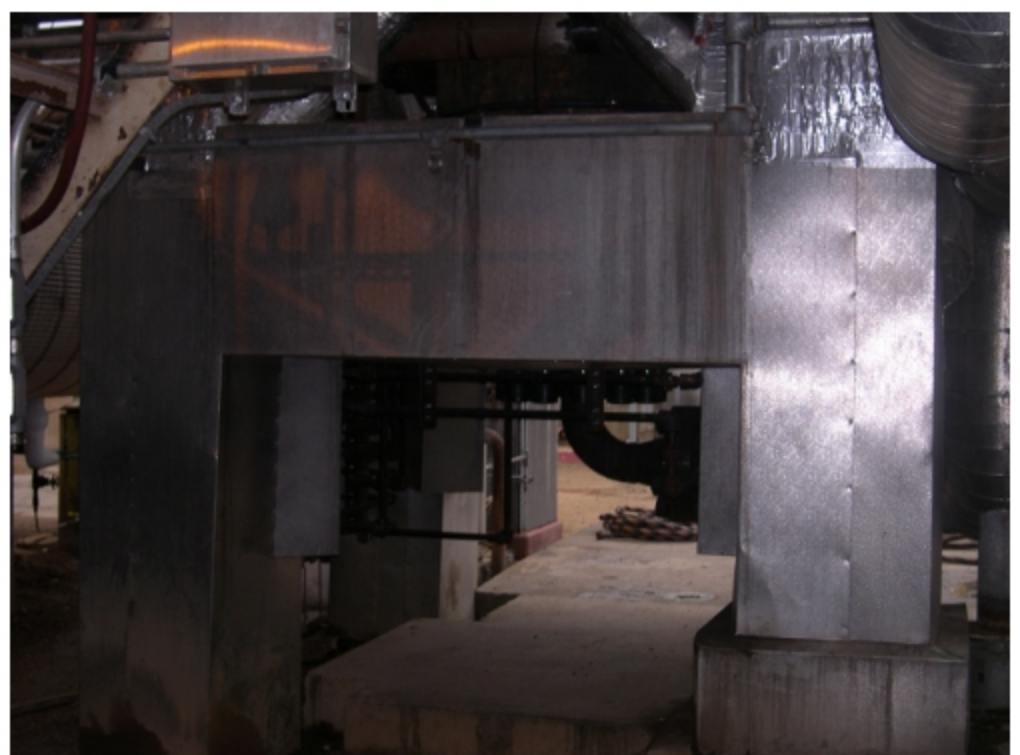
*Repaired Steel Encased Concrete Structure with Fire Resistant Insulation*

The final stage combined a sliding steel collar and frame system. The collar pressed up against the underside of the original concrete slab, which balanced the vessel. Eight powerful hydraulic jacks were positioned to slowly shift the weight of the vessel from the old concrete columns to the new steel cladding. The fire-damaged concrete had actually compressed and the jacks were needed for restoration to the original height before the steel structure could begin to carry the load.

Everyone held their breath as the jacks eased the collar into place. To measure the incremental movement as the steel frame moved to its final position, dial extensometers, capable of measuring fractions of a millimeter, were placed between the sliding collar and the steel encasement. When the needed jacking force was reached and the measurements agreed with the calculations, welders scrambled up the tower to weld the steel cladding in place and make the load transfer permanent.
