Carefully now...

The Fall Creek bridge was originally built in 1948. Its riveted steel plate girders span 106 feet, about 50 feet above the creek bed. The deep gorge, with its vertical rocky walls, combined with the strict environmental regulations that have been put in place since the bridge was originally built means you can't exactly stand under it to do repairs.

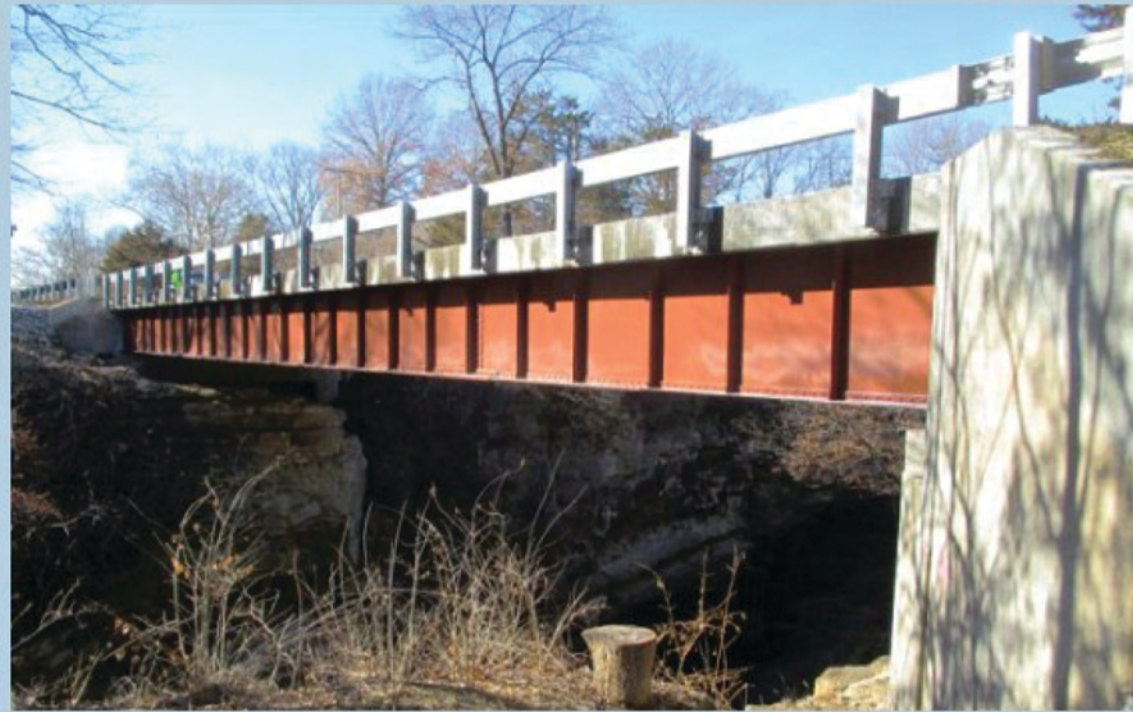
The 70-year-old bridge was suffering serious degradation, to the point where a complete replacement was considered. But the challenging terrain made that extremely difficult and the County asked WHKS engineers to explore the idea of a rehab. The first step was to see if it was even possible to bring the old structure up to current specifications.

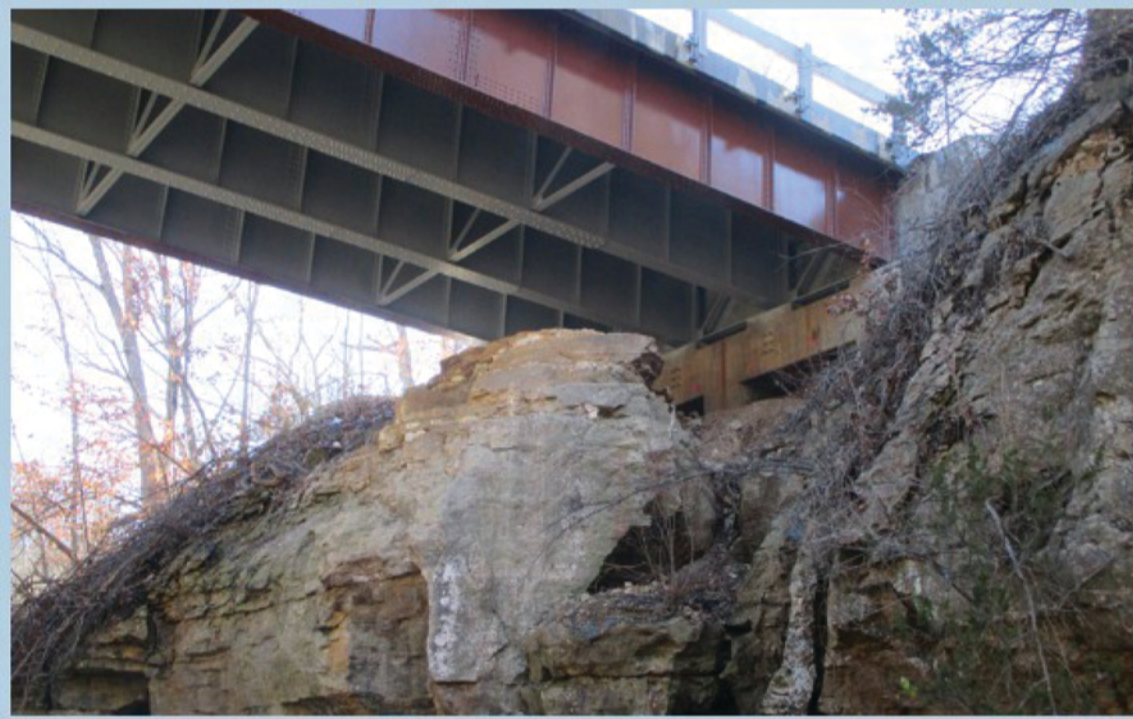
Hanging off the side of the bridge in a 'snooper' is nerve-wracking experience. Inspectors ride in a truck-mounted bucket that goes over the side and then under the bridge, leaving the occupants hanging in mid-air. But this vantage point allowed the NBIS certified engineers to conduct a detailed inspection of every girder and plate in the bridge.

The inspection concluded that a bridge rehab was, indeed, possible and less expensive than a total replacement. But it would require adding new steel plating to the existing girders, splicing of new steel where the original was too corroded, reinforcing of the stiffening braces and a new composite concrete deck.

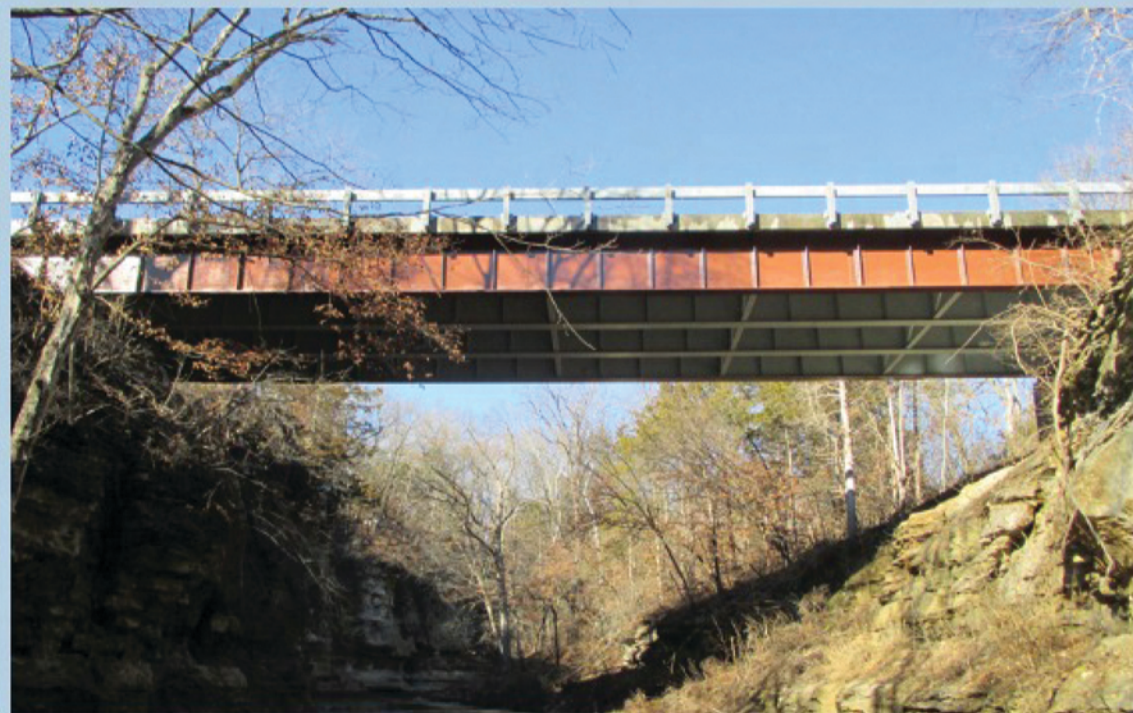
Not surprisingly, once the work was underway and contractors were removing and uncovering more structural elements, they discovered even more areas of deterioration. The engineers were on call and developed the repair details on the fly as the contractor incorporated them into the work. This kind of cooperation and responsiveness between Adams County, the contractor and the engineering team was crucial to getting this tricky job done on time.
