Cedar Street Bridge

Overall Elevation of the Cedar Street Bridge

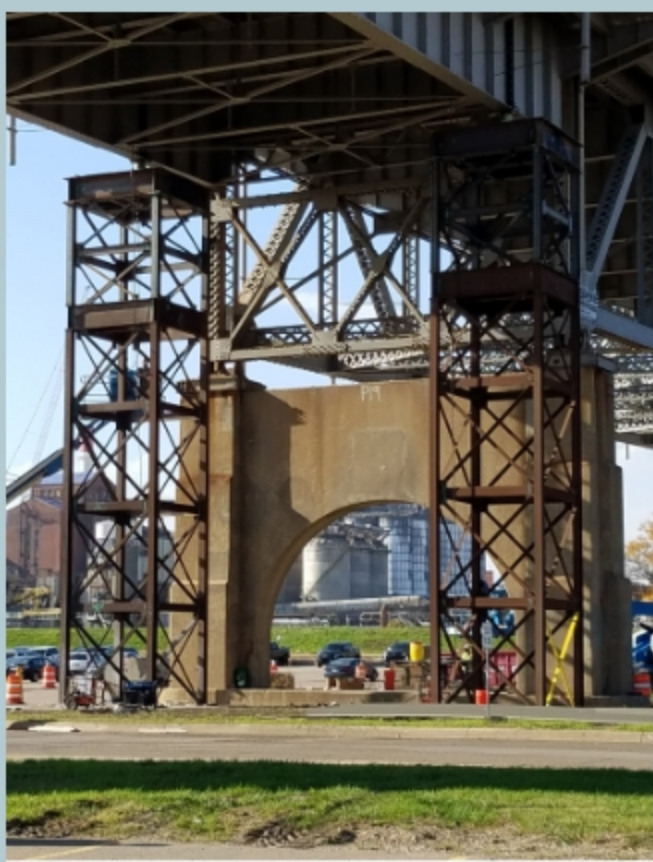
40 foot tall custom shoring towers at Pier 19 used to complete the end frame replacement

For example, the team designed a custom scaffolding platform using specially designed structural steel brackets to allow workers to repair the deck slab, parapet and expansion joints. Two 40 foot tall shoring towers were built to temporarily support the east approach span, so contractors could remove and replace an entire bridge end frame. And a temporary support system held up the main truss cantilever, allowing workers to replace the main span pin and link assemblies, which allow the bridge to transfer heavy traffic loads and accommodate thermal expansion.

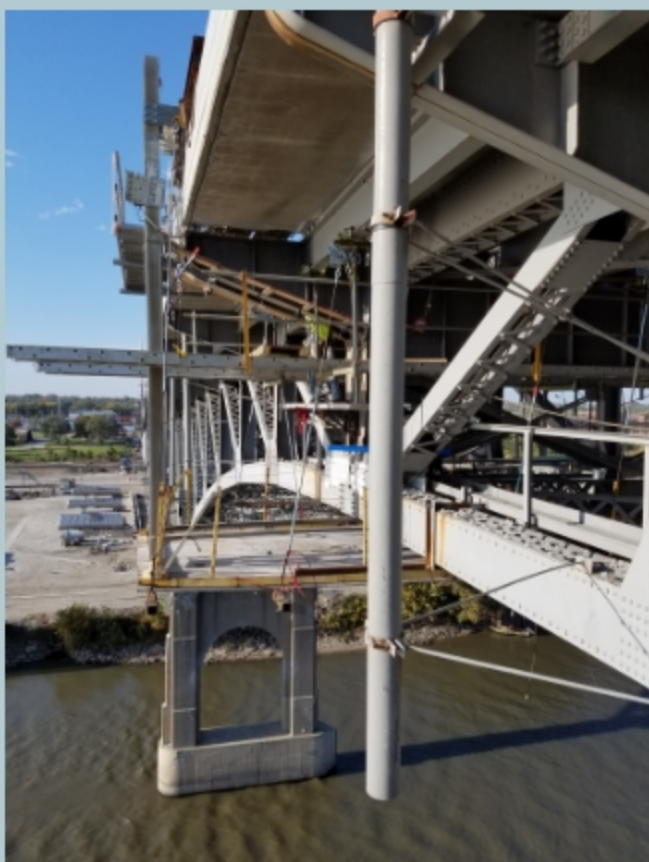
Custom designed scaffolding system used to complete miscellaneous overhead bridge repairs

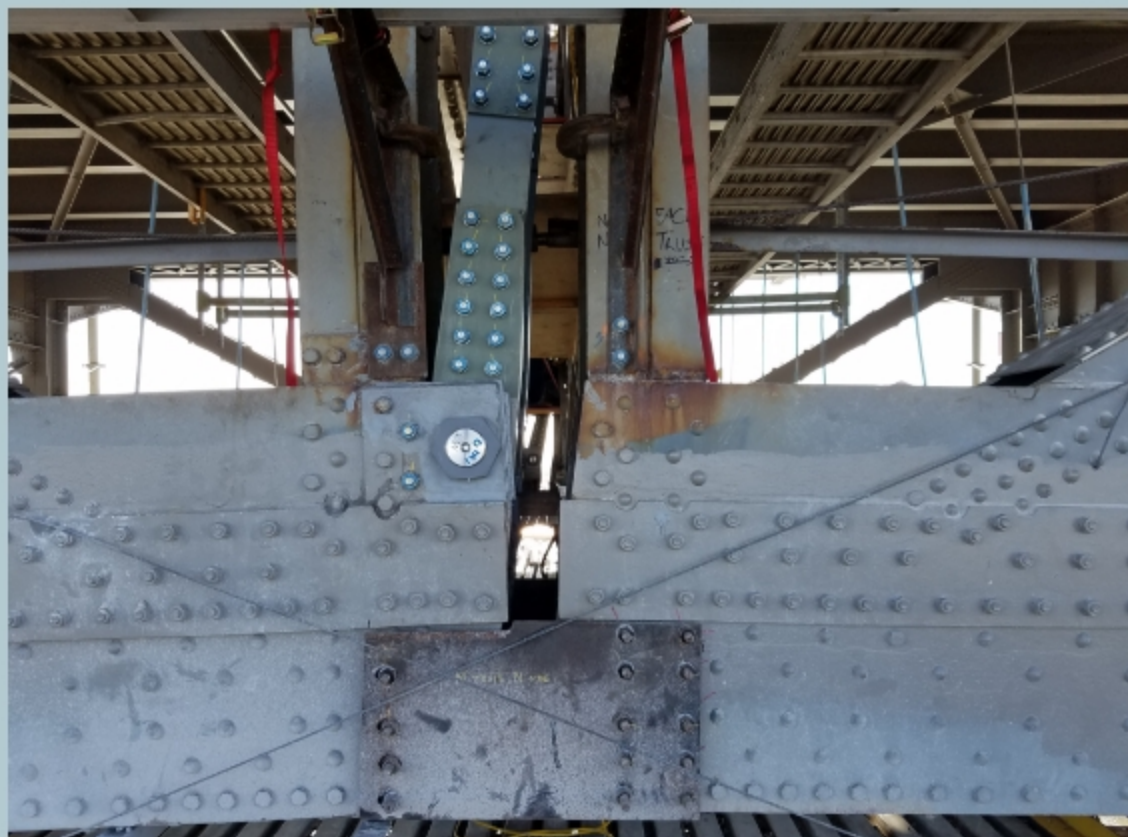
Essential support system used to complete the main cantilever truss pin and link assembly replacement
