Lifting A 60 Year Old Bridge While Traffic Flows Above

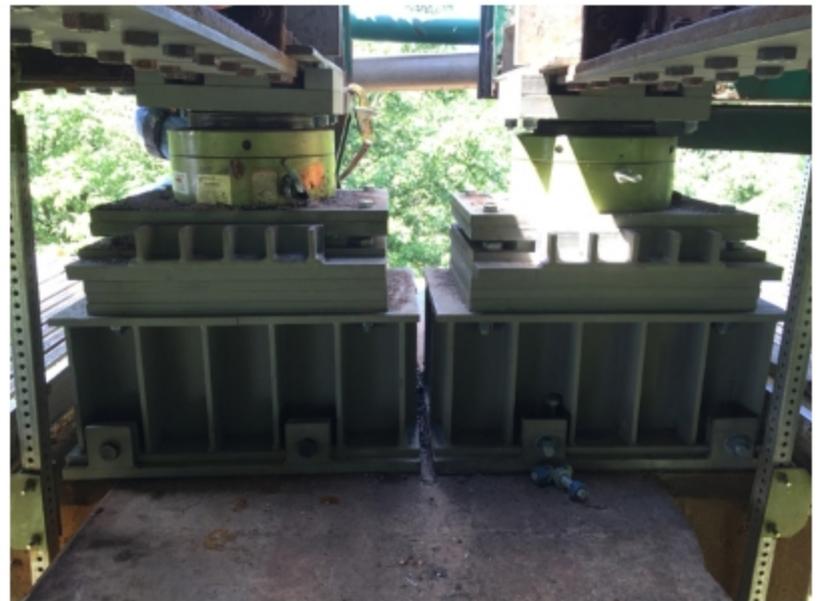
Jacking system under the end floorbeams

After examining numerous approaches, the engineers of WHKS developed a complex solution. Powerful jacks were inserted under the bridge structure and were set on sliding surfaces to allow thermal expansion of approximately two inches. A complex strengthening system was designed and bolted to the existing structure to ensure the hundreds of tons could be lifted straight up without any tipping or twisting. Bolting the new strengthening system to the seriously corroded bridge and jacking the structure proved challenging and the structural team had to remain in contact with the bridge contractor continuously to modify and fine-tune the calculations and details.

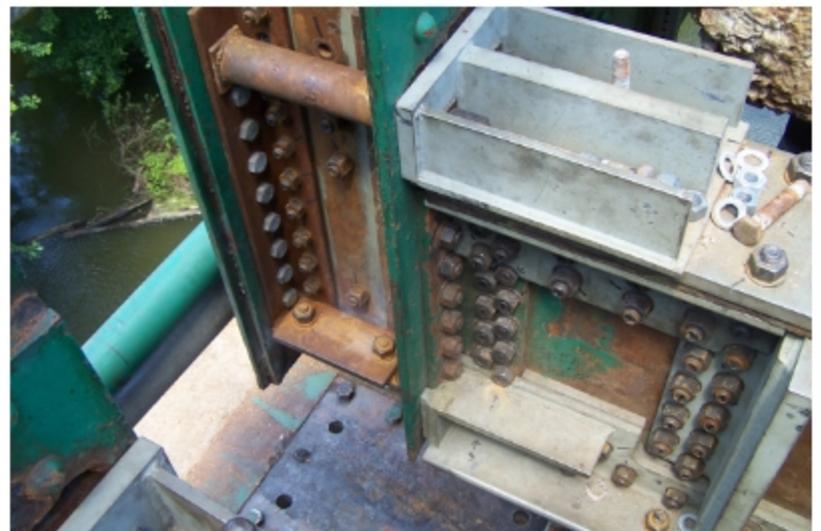
Floorbeam and truss strengthening system
