## Old Bridge. New Techniques.

*Experimental repairs to bridge in Christian County*

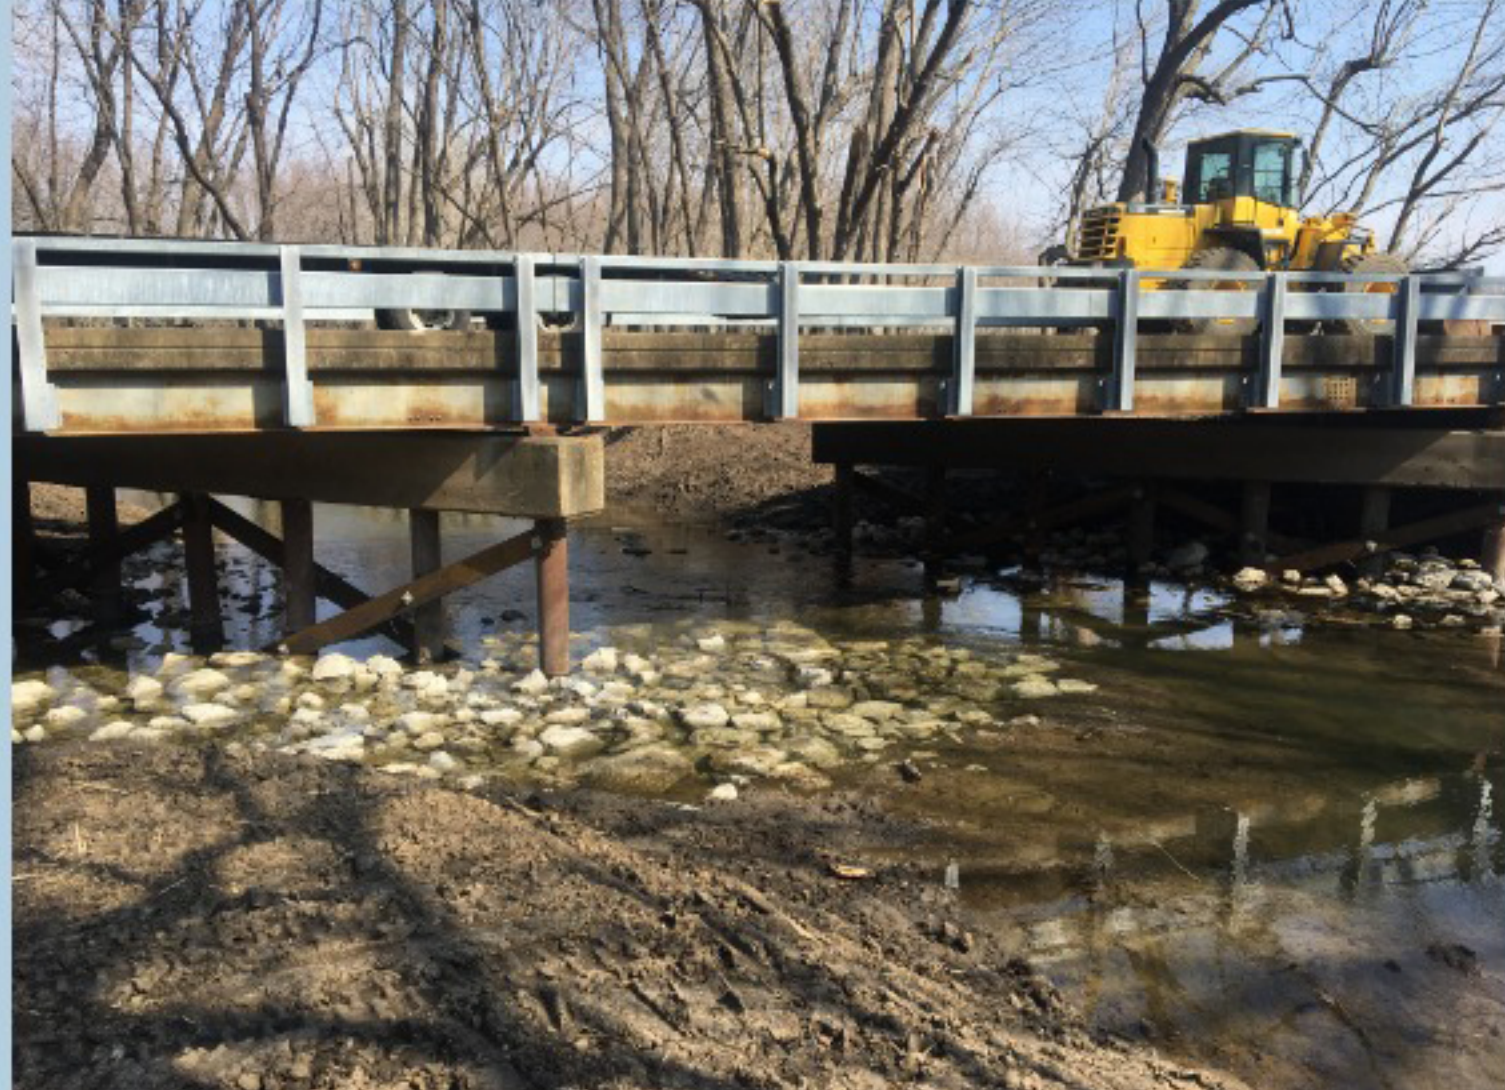
*Bridge Elevation with New Steel Bridge Railing*

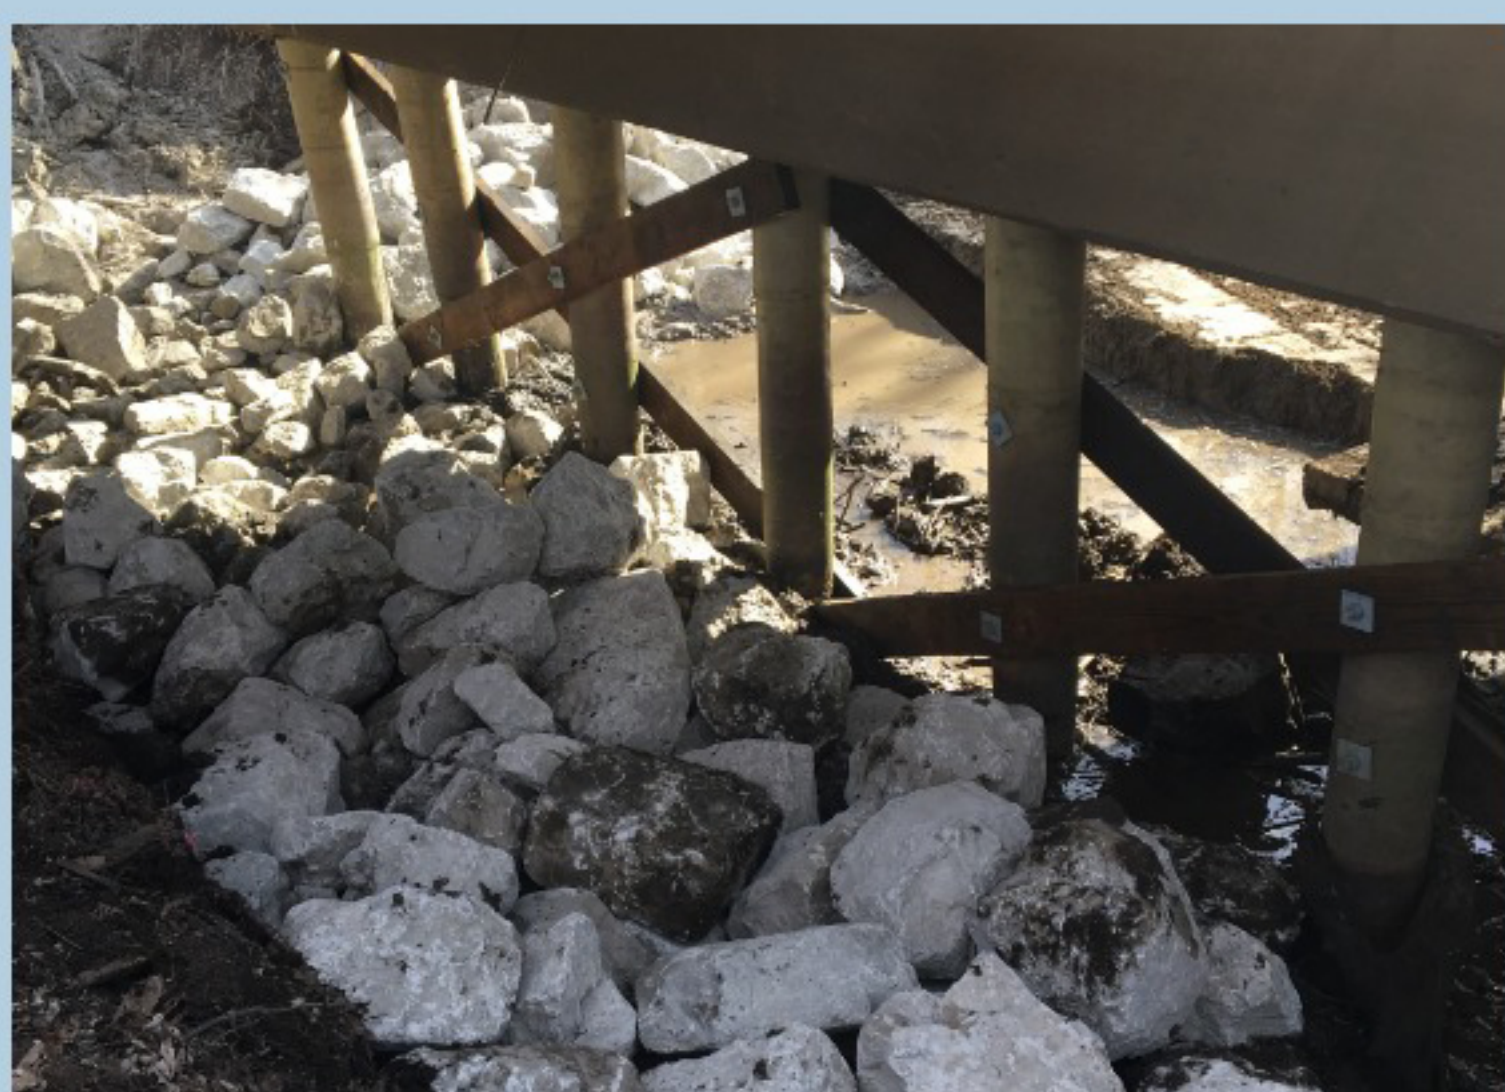
*West Pier - FRP Timber Pile Repairs and New Timber Cross-Bracing*

While some of the piles were repaired traditionally with steel extensions, others were treated using a new approach. After large voids were repaired with a high-strength grout, the wood pile was wrapped with multiple layers of fiber-reinforced polymer cladding. This wrapping provides structural reinforcement to the timber while sealing and protecting it from the elements into the future. While still experimental, engineers believe the technique can add significant life to old timber structures.

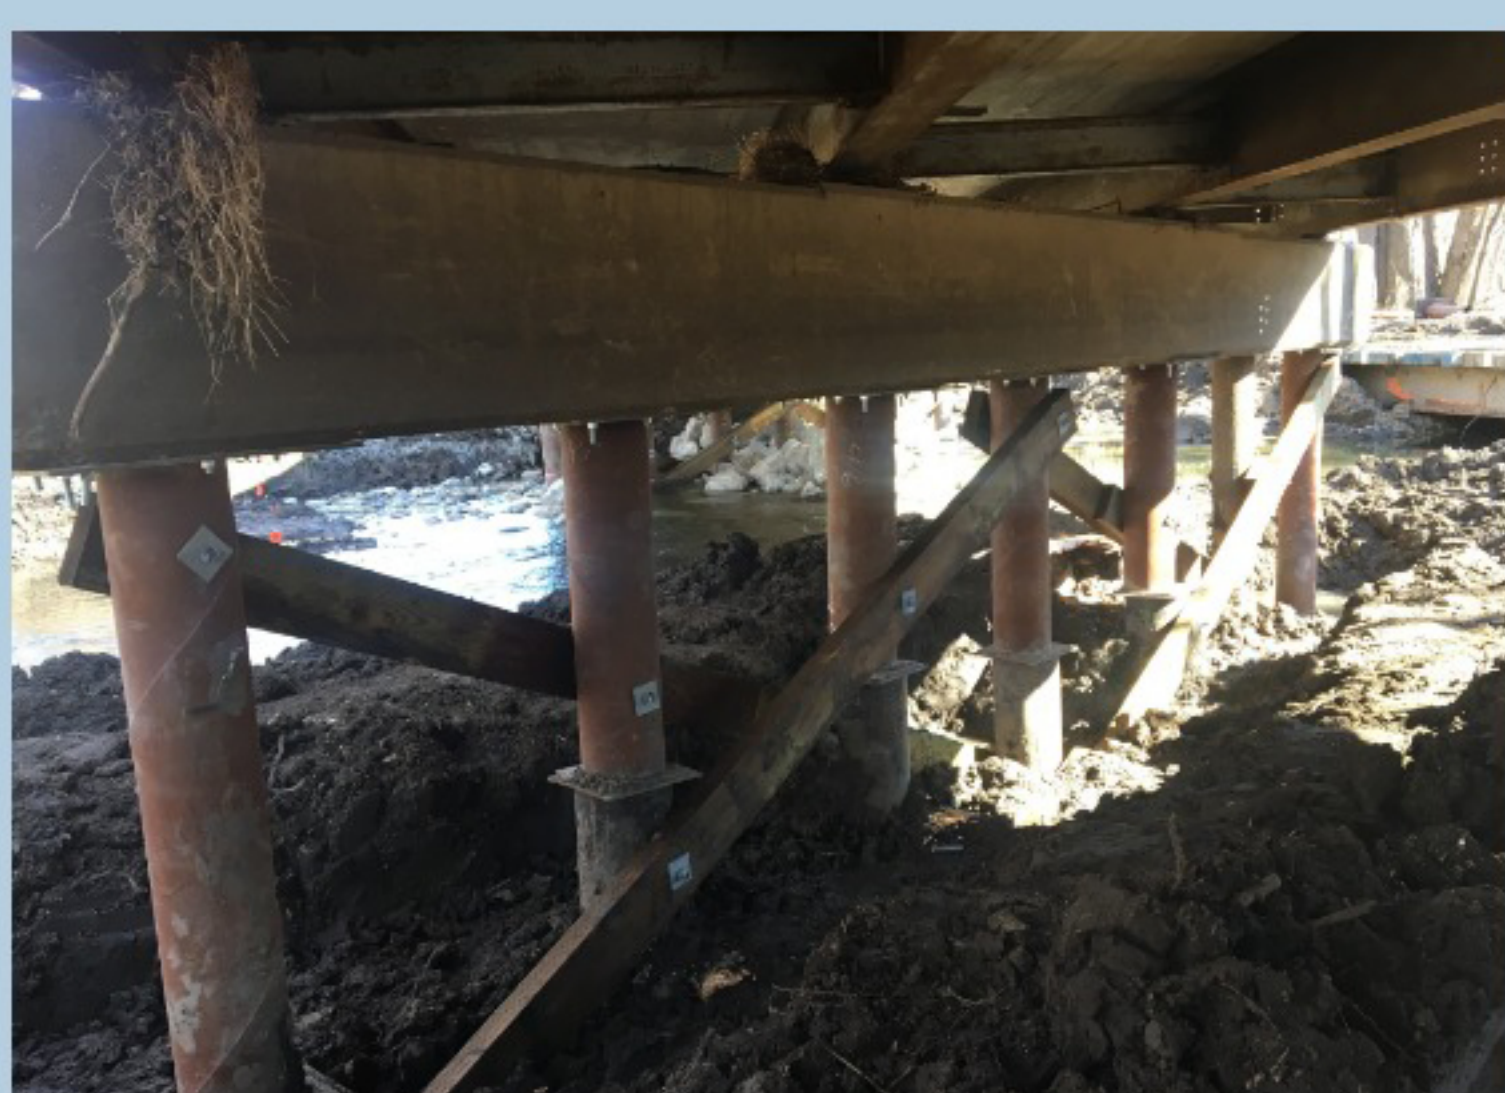
*Center Pier - Traditional Steel Repairs and New Timber Cross-Bracing*
