If it ain't one thing, it's another

Camp Lincoln Bridge

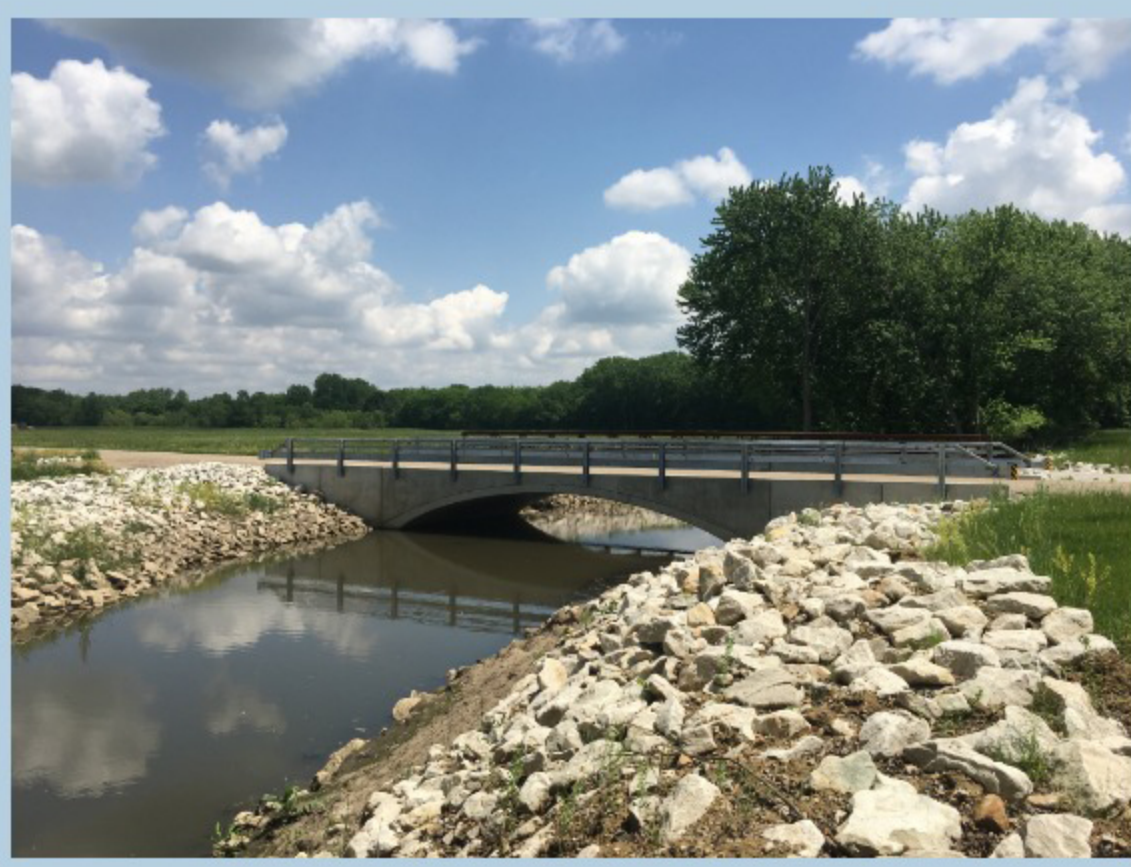
To begin, the creek floods regularly and constructing a new bridge above flood level would have required raising the surrounding banks by 15 feet. So a 'submersible' bridge - essentially a 3-sided, precast concrete culvert - was designed. The precast elements would be dropped into place and then backfilled.
