Bridge Arthritis

Old wooden bridges are like grandparents. They've sagged in places and don't move quite the same any more, but we like them to be around. When the Wilkinson Park covered bridge burned down in the mid 1990s, a group of volunteers and donors stepped up to replace it. Lots of enthusiasm and generosity, but some deviation from the original plans.

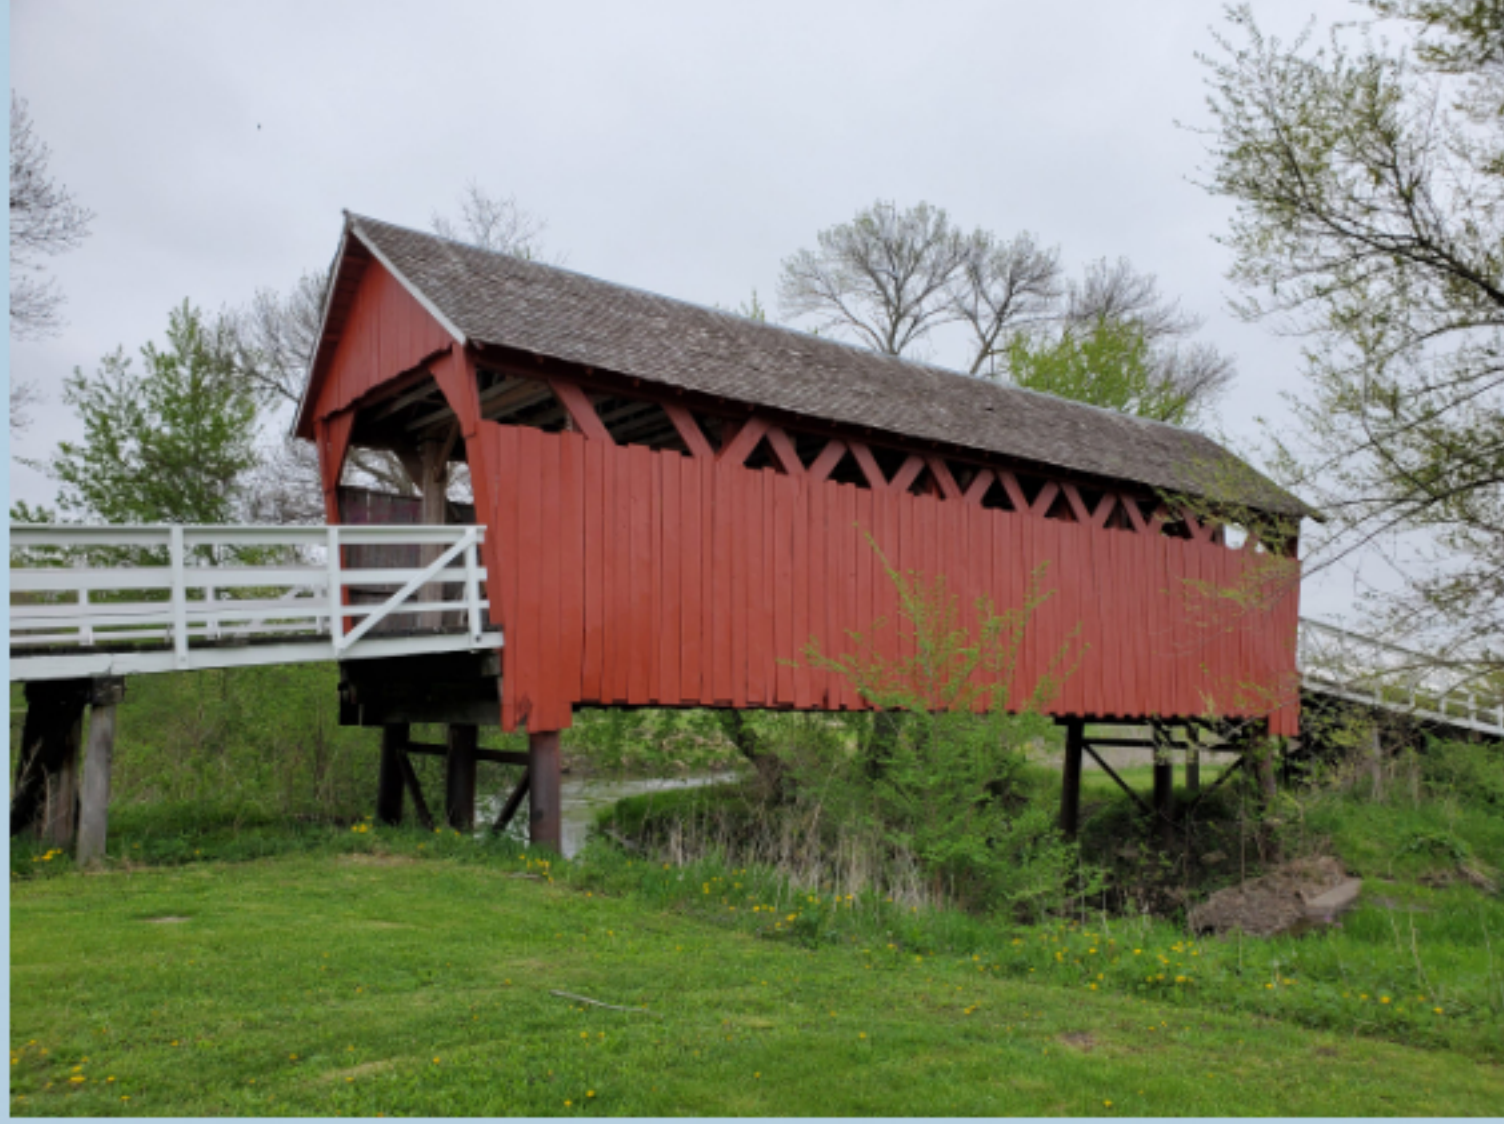
The timber for the bridge was cottonwood, a native lumber from donated trees that were cut to size by a local saw mill. Over 20 years the wood had shrunk, warped and sagged to the point where the safety of the bridge was of serious concern. The slow, but unrelenting movement caused the whole structure to twist in a way that put new stresses and loads on beams that were not intended to support.

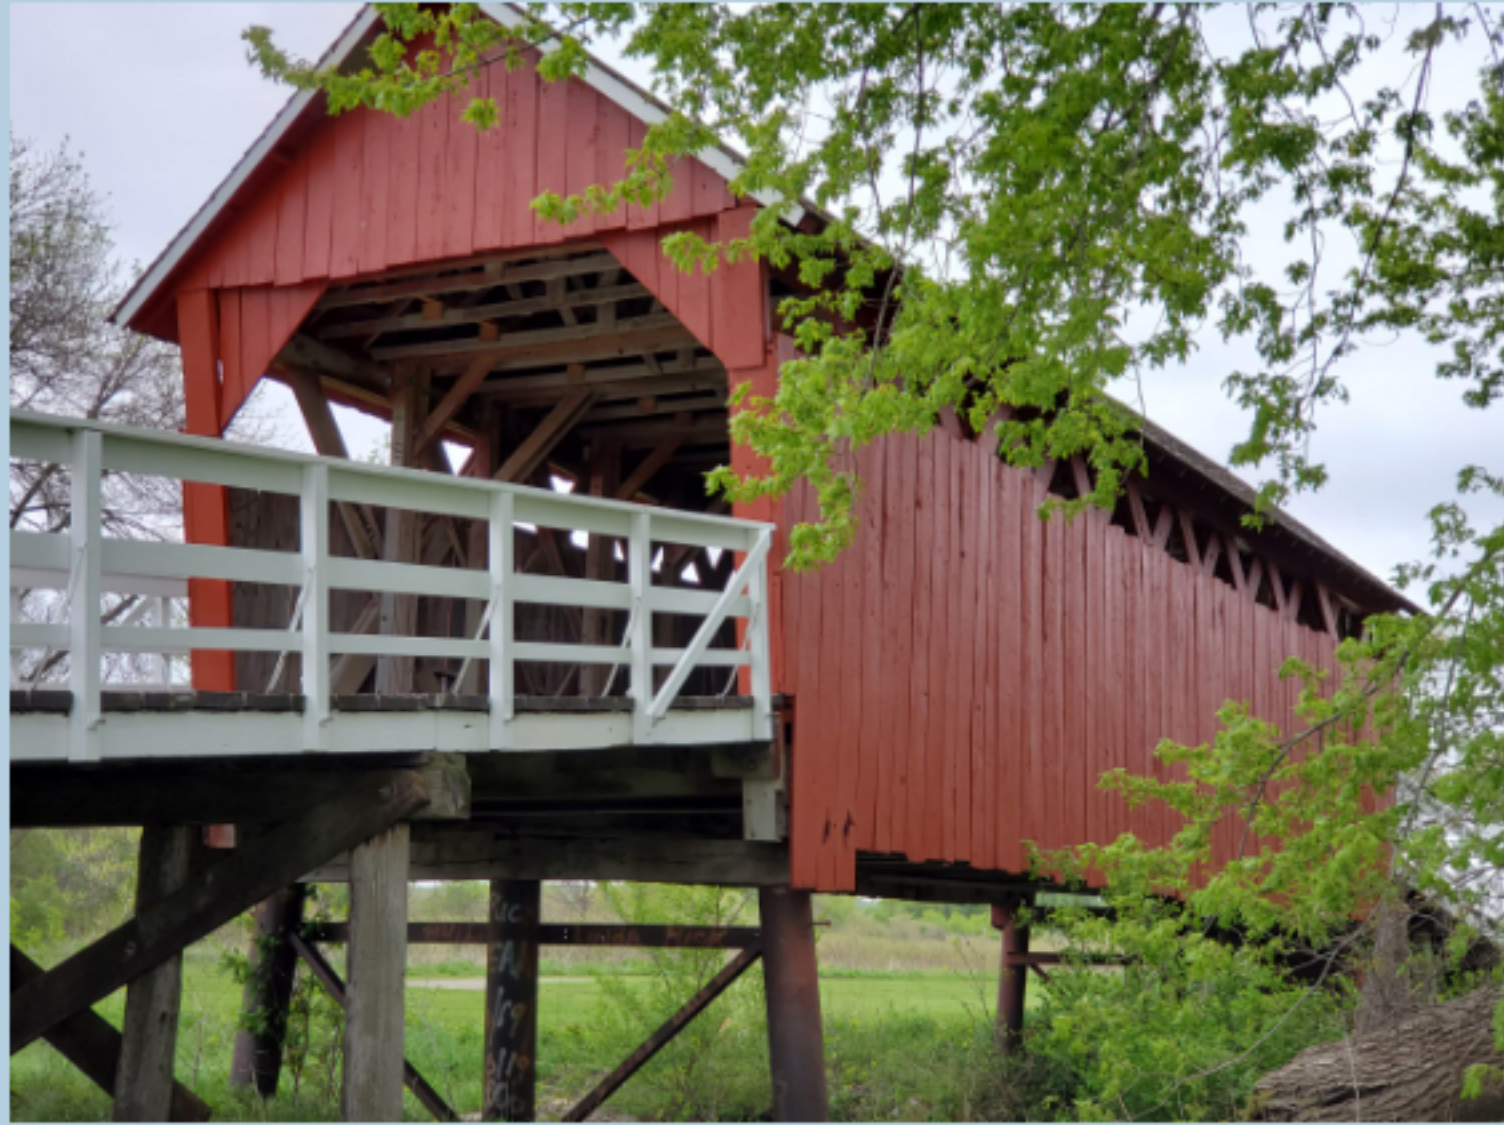
WHKS engineers were asked to inspect and monitor the bridge. Eventually, though, it reached the point where collapse was possible if nothing was done. The bridge was closed and the engineering team set about developing a plan to straighten it out, stiffen it and let it get back to being the spot for stolen kisses that covered bridges are supposed to be.

But, like your grandpa, old things don't straighten out so easily. Slow and careful jacking was able to get it back into a reasonable state of alignment. A timber that took 20 years to warp isn't going to be made straight in a day.

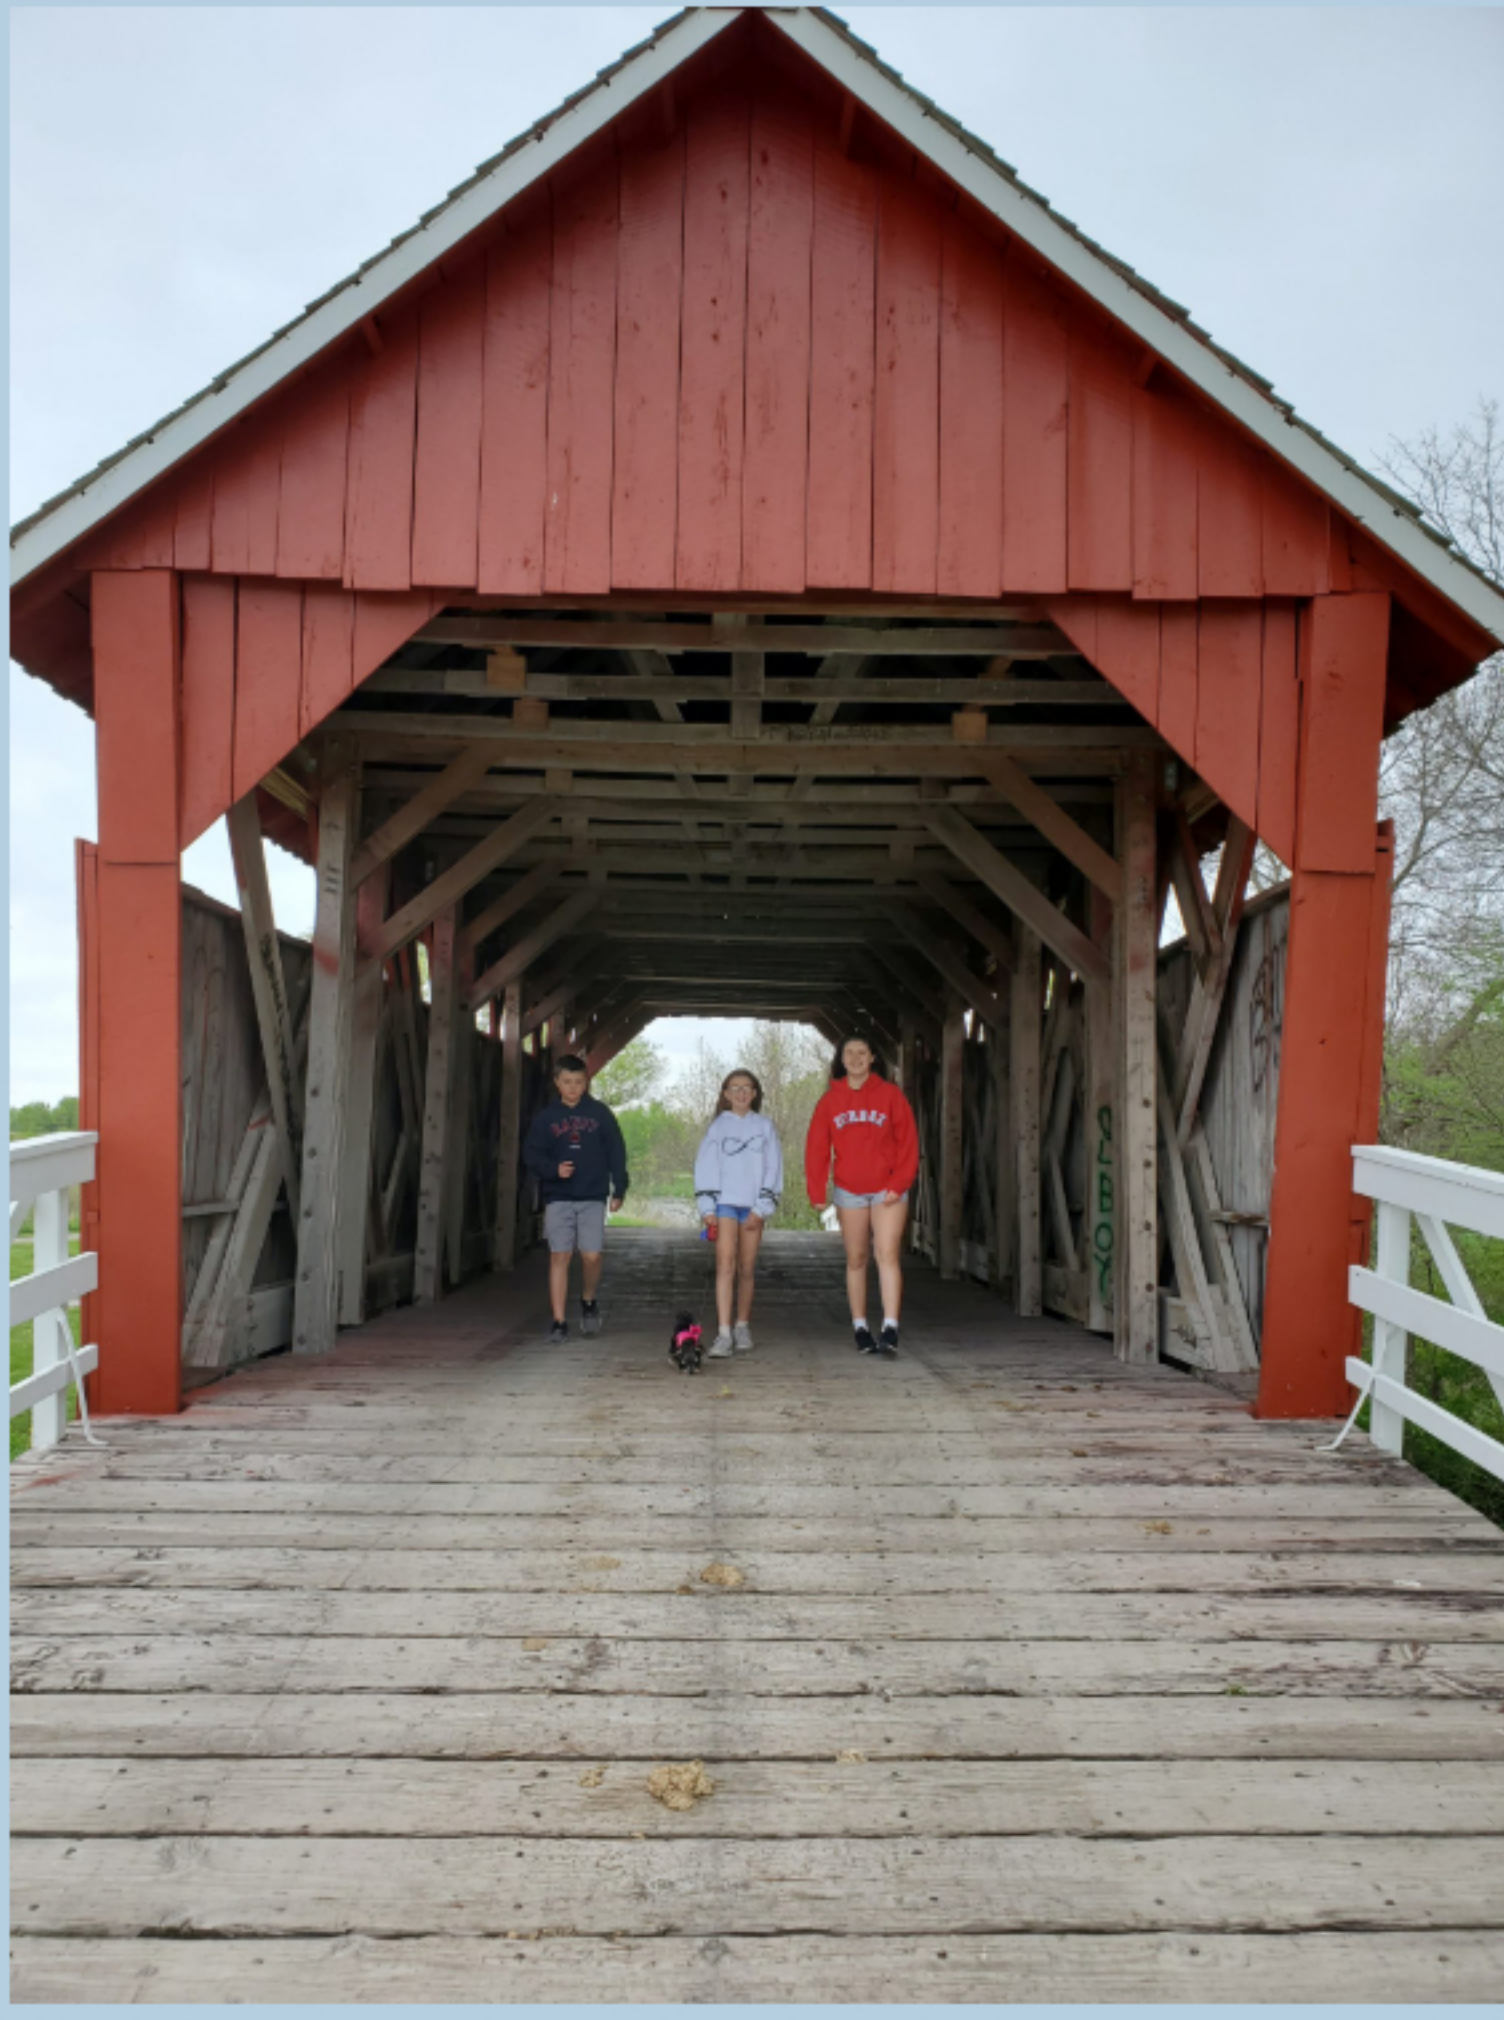
It would have been much simpler to design and install a bracing system on the outside of the bridge. But that would have ruined its charming exterior so the team worked to weave new posts and knee braces through the existing structure on the inside of the bridge. This required some very careful coordination with the contractor as they threaded the new struts through the old without taking the old apart.

The new bracing successfully added a lot of much needed stiffness to the structure. It's now open again and charming park visitors who come looking for another of Iowa's famed covered bridges.
